# Access Compliance Report Public Rights-of-Way (Curb Ramps)

| Main Street: ANTIGUA_ST | | Cross Street: PALAIS_RD | | Location: | NE |
| ADA ID: RPAT211119091120 | Ramp Type: Type 4 - Parallel | Initial Pass/Fail: Pass | Overall Compliance: Yes | Severity Score: | 0 |

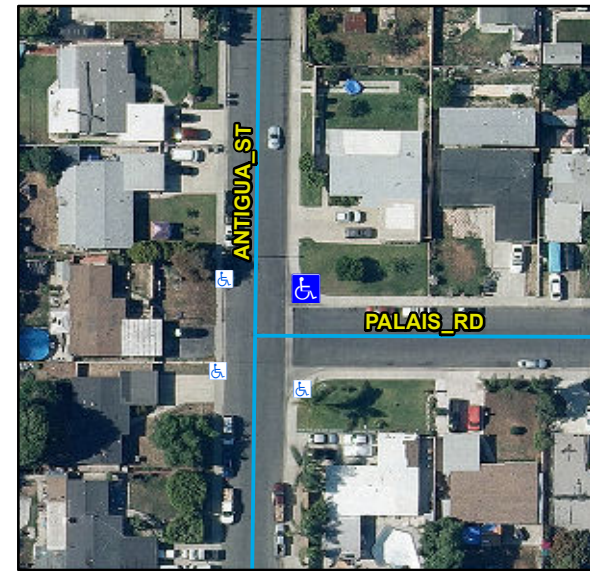
Surveyor Notes:

N/A

Possible Solutions:

N/A

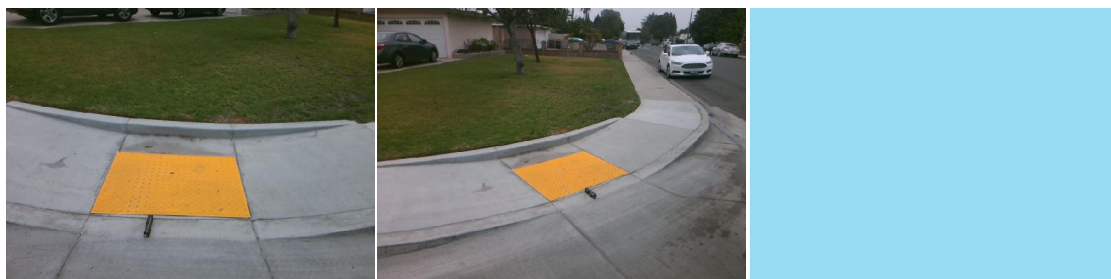
## Obstruction and Utility Measurement/Component Compliance

| Compliance | Description | Data | Compliance | Description | Data |
|---|---|---|---|---|---|
| Yes | Obstructions Present? | No | N/A | Utilities Present? | No |
