# Access Compliance Report Public Rights-of-Way (Curb Ramps)

| Main Street: BROOKHURST_ST | | Cross Street: PALAIS_RD | | Location: | SW |
| ADA ID: RPAT211119093511 | Ramp Type: Type 4 - Parallel | Initial Pass/Fail: Fail | Overall Compliance: No | Severity Score: | 15 |

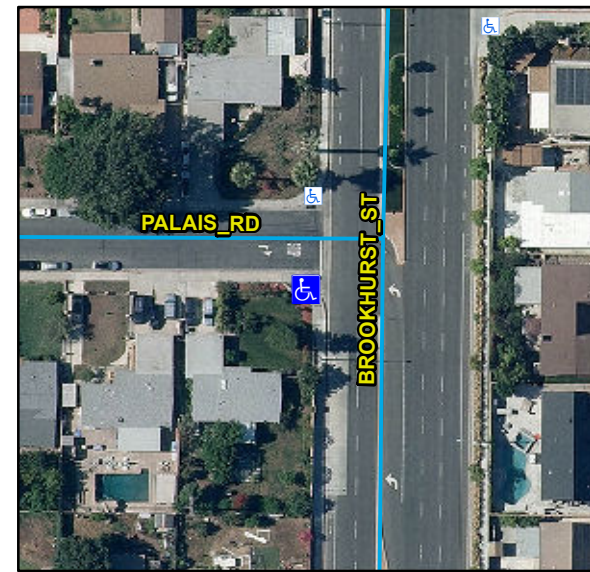
| Compliance | Description | Data | Compliance | Description | Data |
|---|---|---|---|---|---|
| Yes | Ramp Run Slope LT (%) | 6.7 | No | Ramp Run Slope RT (%) | 9 |

Possible Solutions:

**Remove & Replace Curb Ramp With Two New Directional Ramps or Equivalent.**

**R304.3.2, STD 1115**

Total Cost: \$ 4000

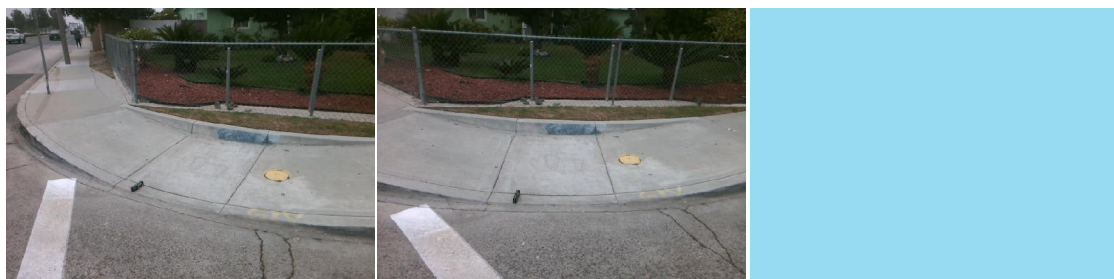
| Compliance | Description | Data | Compliance | Description | Data |
|---|---|---|---|---|---|
| N/A | Ramp Length LT (in) | 74 | N/A | Ramp Length RT (in) | 82 |
| Yes | Ramp Width LT (in) | 66 | Yes | Ramp Width RT (in) | 66 |
| Yes | Ramp Cross Slope LT (%) | 1.4 | Yes | Ramp Cross Slope RT (%) | 1.8 |
