# Access Compliance Report Public Rights-of-Way (Curb Ramps)

Main Street: PALAIS\_RD Cross Street: BROOKHURST\_ST Location: NW

ADA ID: RPAT211119094213 Ramp Type: Type 4 - Parallel Initial Pass/Fail: Fail Overall Compliance: No Severity Score: 15

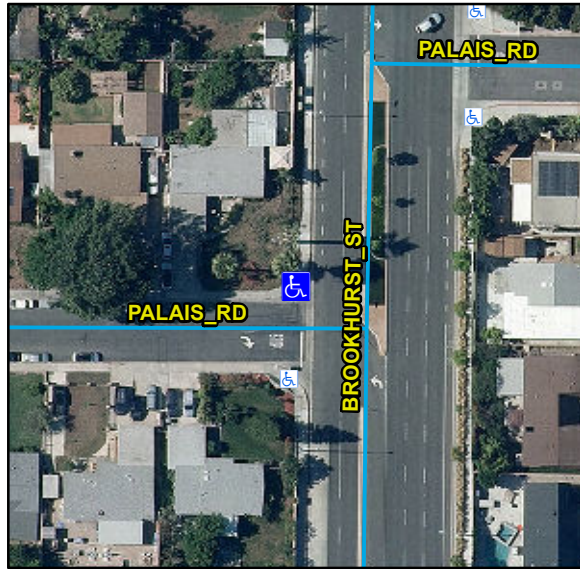
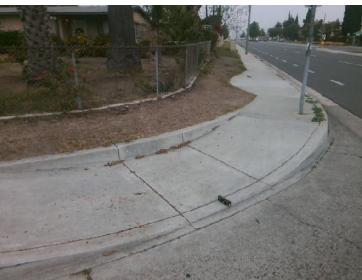
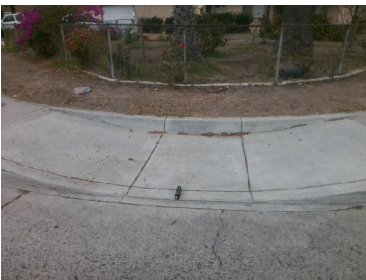
| Compliance | Description | Data | Compliance | Description | Data |
|---|---|---|---|---|---|
| No | Ramp Run Slope LT (%) | 10.4 | No | Ramp Run Slope RT (%) | 9 |

Remove & Replace Curb Ramp With Two New Directional Ramps or Equivalent.

R304.3.2, STD 1115
