# Access Compliance Report Public Rights-of-Way (Curb Ramps)

Main Street: HARRIET\_LN Cross Street: GILBERT\_ST Location: SE

ADA ID: RPAT211119131206 Ramp Type: Type 4 - Parallel Initial Pass/Fail: Fail Overall Compliance: No Severity Score: 15

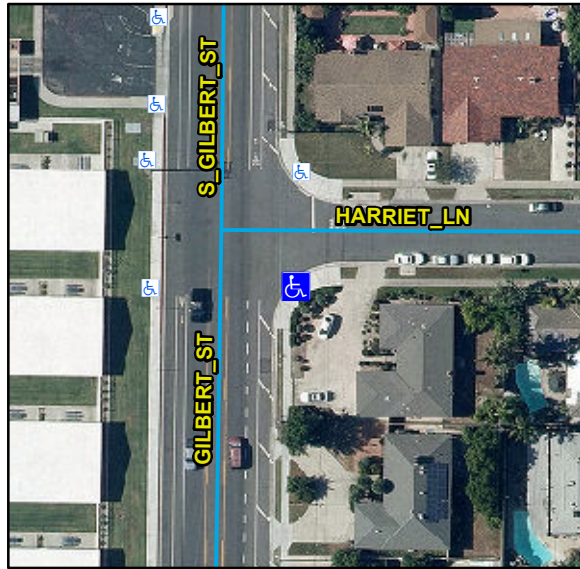
| Compliance | Description | Data | Compliance | Description | Data |
|---|---|---|---|---|---|
| No | Ramp Cross Slope LT (%) | 6.6 | No | Ramp Cross Slope RT (%) | 5.7 |

**Remove & Replace Curb Ramp With Two New Directional Ramps or Equivalent.**

**R304.5.3, STD 1115**
