# Access Compliance Report Public Rights-of-Way (Curb Ramps)

Main Street: N/A Cross Street: S\_GILBERT\_ST Location: NW

ADA ID: RPAT211119132118 Ramp Type: Type 7 - Directional 2 Initial Pass/Fail: Pass Overall Compliance: No Severity Score: 4

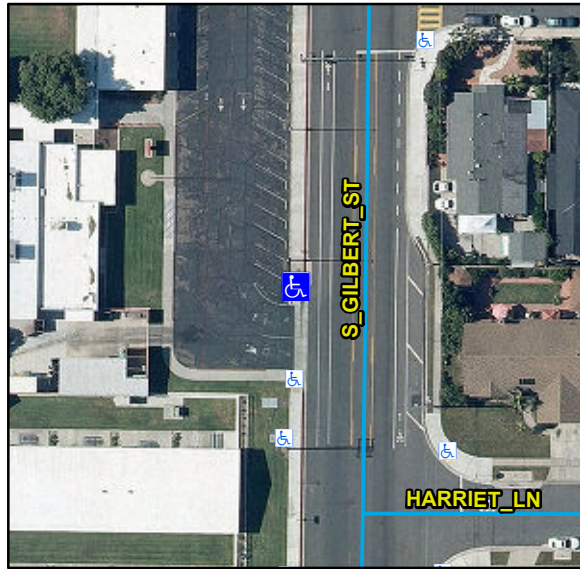
| Compliance | Description | Data | Compliance | Description | Data |
|---|---|---|---|---|---|
| No | Landing Length (in) | 42 | Yes | DWS Length (in) | 62 |
| No | Landing Width (in) | 42 | Yes | DWS Full Width | Yes |

Remove & Replace Landing.

R304.2.1, STD 1115
