# Access Compliance Report Public Rights-of-Way (Curb Ramps)

| Main Street: N/A | | Cross Street: S_GILBERT_ST | | Location: | SW |
| ADA ID: RPAT211119132534 | Ramp Type: Type 4 - Parallel | Initial Pass/Fail: Fail | Overall Compliance: No | Severity Score: | 45 |

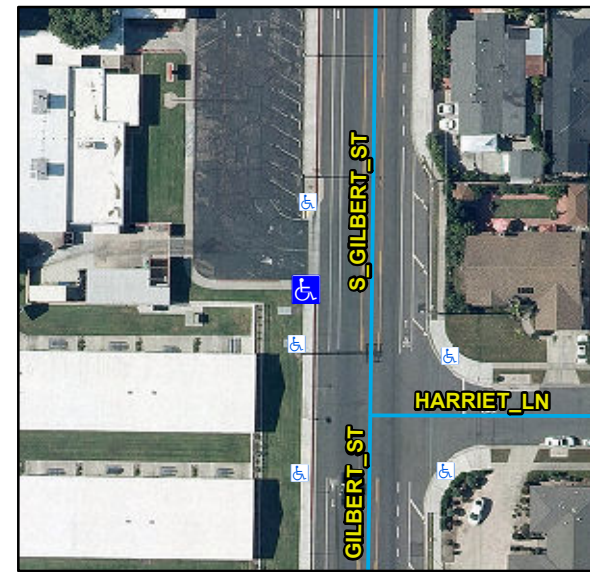
| Compliance | Description | Data | Compliance | Description | Data |
|---|---|---|---|---|---|
| Yes | Ramp Run Slope LT (%) | 8 | No | Ramp Run Slope RT (%) | 9.7 |
| No | Ramp Cross Slope LT (%) | 8.6 | Yes | Ramp Cross Slope RT (%) | 1.4 |

Remove & Replace Entire Ramp.

R204.3, R304.5.3, R304.3.2, STD 1115

\$ 2000

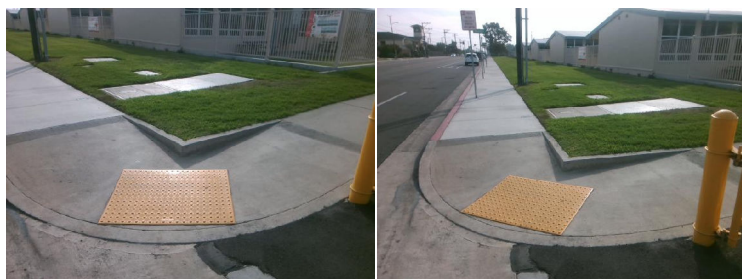
| Compliance | Description | Data | Compliance | Description | Data |
|---|---|---|---|---|---|
| N/A | Ramp Length LT (in) | 68 | N/A | Ramp Length RT (in) | 68 |
| Yes | Ramp Width LT (in) | 69 | Yes | Ramp Width RT (in) | 61 |
