# Access Compliance Report Public Rights-of-Way (Curb Ramps)

Main Street: GILBERT\_ST Cross Street: HARLE\_AVE Location: NE

ADA ID: RPAT211122120230 Ramp Type: Type 4 - Parallel Initial Pass/Fail: Pass Overall Compliance: Yes Severity Score: 0

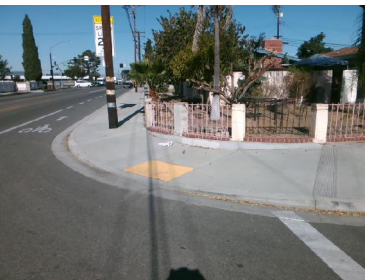
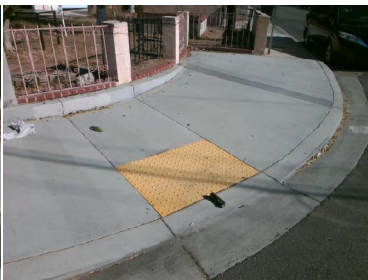
| Compliance | Description | Data | Compliance | Description | Data |
|---|---|---|---|---|---|
| Yes | Overall Surface Condition | Acceptable | | | |

Possible Solutions:

N/A
