# Access Compliance Report Public Rights-of-Way (Curb Ramps)

| Main Street: CERRITOS_AVE | | Cross Street: GILBERT_ST | | Location: | SE |
| ADA ID: RPAT211122120721 | Ramp Type: Type 4 - Parallel | Initial Pass/Fail: Fail | Overall Compliance: No | Severity Score: | 2 |

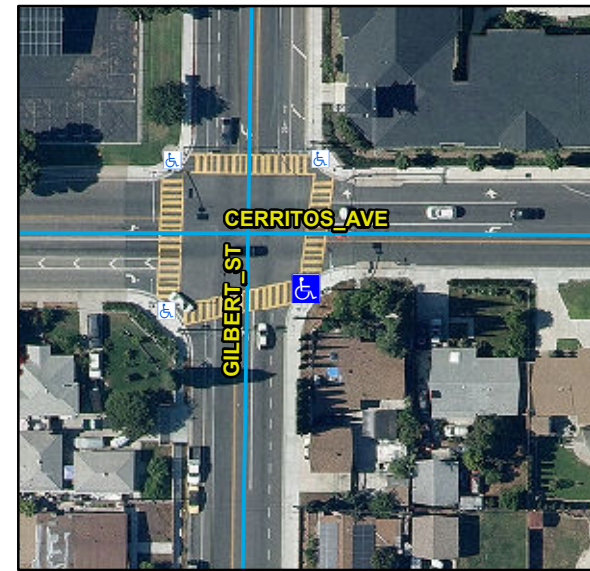
| Compliance | Description | Data | Compliance | Description | Data |
|---|---|---|---|---|---|
| No | Ramp Cross Slope LT (%) | 2.9 | No | Ramp Cross Slope RT (%) | 3.4 |

**Remove & Replace Curb Ramp With Two New Directional Ramps or Equivalent.**

**R304.5.3, STD 1115**

Total Cost: \$ 4000
