# Access Compliance Report Public Rights-of-Way (Curb Ramps)

Main Street: GILBERT\_ST Cross Street: CERRITOS\_AVE Location: NE

ADA ID: RPAT211122121013 Ramp Type: Type 4 - Parallel Initial Pass/Fail: Fail Overall Compliance: No Severity Score: 15

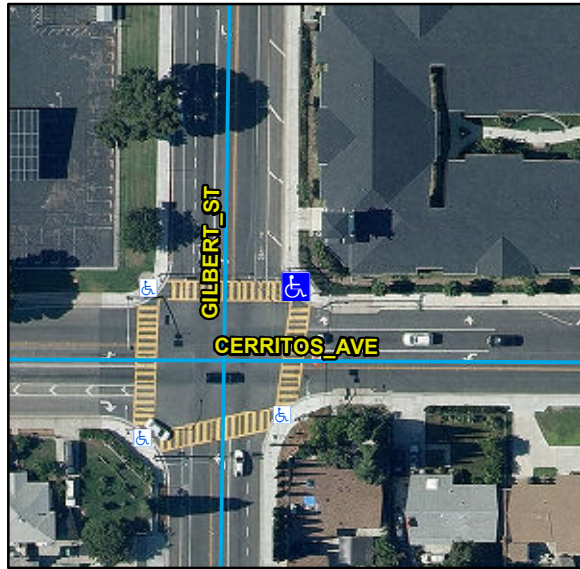
| Compliance | Description | Data | Compliance | Description | Data |
|---|---|---|---|---|---|
| Yes | Ramp Run Slope LT (%) | 7.8 | No | Ramp Run Slope RT (%) | 8.6 |

**Remove & Replace Curb Ramp With Two New Directional Ramps or Equivalent.**

**R304.3.2, STD 1115**

Total Cost: \$ 4000
