# Access Compliance Report Public Rights-of-Way (Curb Ramps)

| Main Street: CERRITOS_AVE | | Cross Street: GILBERT_ST | | Location: | NW |
| ADA ID: RPAT211122121443 | Ramp Type: Type 4 - Parallel | Initial Pass/Fail: Fail | Overall Compliance: No | Severity Score: | 2 |

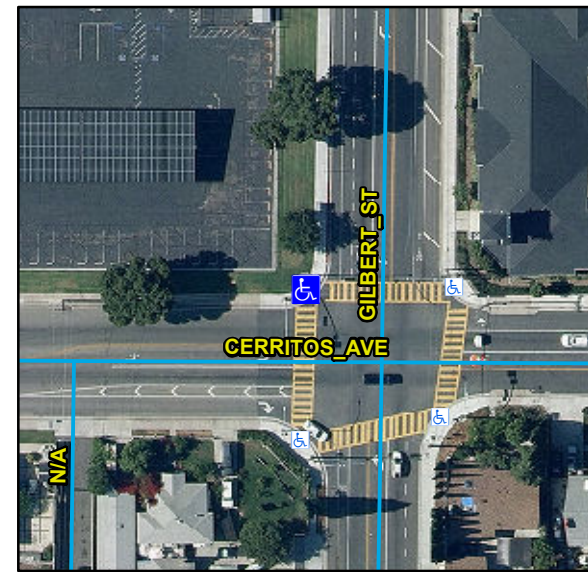
| Compliance | Description | Data | Compliance | Description | Data |
|---|---|---|---|---|---|
| No | Ramp Cross Slope LT (%) | 2.3 | Yes | Ramp Cross Slope RT (%) | 0.8 |

Possible Solutions:

**Remove & Replace Curb Ramp With Two New Directional Ramps or Equivalent.**

**R304.5.3, STD 1115**
