# Access Compliance Report Public Rights-of-Way (Curb Ramps)

Main Street: **DESSER\_LN** Cross Street: **HARLE\_AVE** Location: **SW**

ADA ID: **RPAT211122131904** Ramp Type: **Type 4 - Parallel** Initial Pass/Fail: **Pass** Overall Compliance: **No** Severity Score: **5**

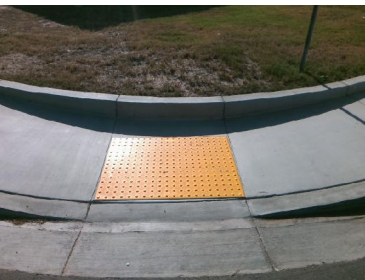
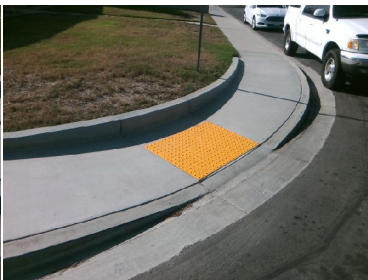
| Compliance | Description | Data | Compliance | Description | Data |
|---|---|---|---|---|---|
| <b>Yes</b> | Gutter Ponding | <b>No</b> | <b>No</b> | Curb Slope | <b>11.8</b> |
| <b>No</b> | Gutter Run Slope (%) | <b>6</b> | | Road Cross Slope (%) | <b>3.7</b> |

**Remove & Replace Curb Slope. Remove & Replace Gutter.**
