# Access Compliance Report Public Rights-of-Way (Curb Ramps)

Main Street: N/A Cross Street: PACIFIC\_AVE Location: NW

ADA ID: RPAT211122134512 Ramp Type: Type 7 - Directional 2 Initial Pass/Fail: Fail Overall Compliance: No Severity Score: 2

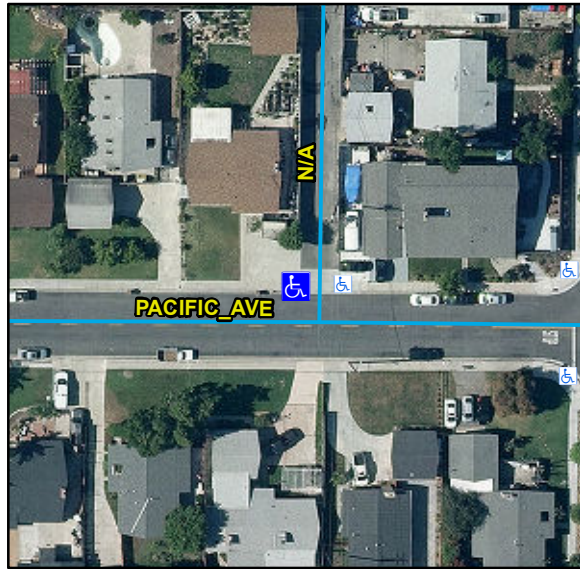
| Compliance | Description | Data | Compliance | Description | Data |
|---|---|---|---|---|---|
| No | Ramp Cross Slope (%) | 2.1 | N/A | Flare Traversable LT | N/A |

Remove & Replace Entire Ramp.

R304.5.3, STD 1115

\$ 3080
