# Access Compliance Report Public Rights-of-Way (Curb Ramps)

Main Street: N/A Cross Street: PACIFIC\_AVE Location: NE

ADA ID: RPAT211122134711 Ramp Type: Type 7 - Directional 2 Initial Pass/Fail: Pass Overall Compliance: No Severity Score: 6

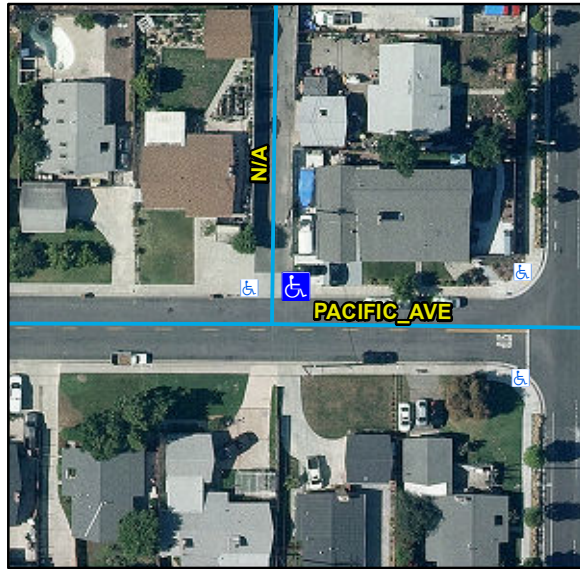
| Compliance | Description | Data | Compliance | Description | Data |
|---|---|---|---|---|---|
| No | Grade Break Slope (%) | 5.8 | | | None |
| Yes | Landing Width (in) | 55 | No | DWS Full Width | No |
| No | Landing Run Slope (%) | 2.2 | | DWS Offset Type | Multiple |
| No | Landing Cross Slope (%) | 3.2 | Yes | DWS Left Offset (in) | 6 |
| No | Gutter Cross Slope (%) | 2.4 | | Parallel Ramp Side | Left |

**Remove & Replace Entire Ramp. Remove & Replace Gutter.**

**R304.2.2-Perp, R304.3.2-Para, R304.5.3, R305.1.4, STD 1115**
