# Access Compliance Report Public Rights-of-Way (Curb Ramps)

Main Street: PACIFIC\_AVE Cross Street: S\_BROOKHURST\_ST Location: NW

ADA ID: RPAT211122135032 Ramp Type: Type 1 - Perpendicular Initial Pass/Fail: Pass Overall Compliance: No Severity Score: 0

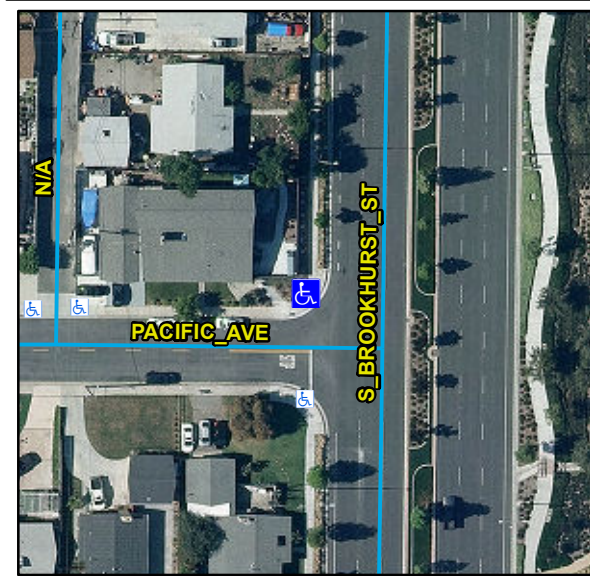
| Compliance | Description | Data | Compliance | Description | Data |
|---|---|---|---|---|---|
| Yes | Gutter Ponding | No | No | Curb Slope | 7.9 |

Possible Solutions:  
**Remove & Replace Entire Ramp.**

OC Std/PROW:  
**R304.2.2, R304.2.1, STD 1115**

Total Cost: \$ 3080
