# Access Compliance Report Public Rights-of-Way (Curb Ramps)

| Main Street: PACIFIC_AVE | | Cross Street: S_BROOKHURST_ST | | Location: | SW |
| ADA ID: RPAT211122135325 | Ramp Type:Type 1 - Perpendicular | Initial Pass/Fail: Pass | Overall Compliance: No | Severity Score: | 5 |

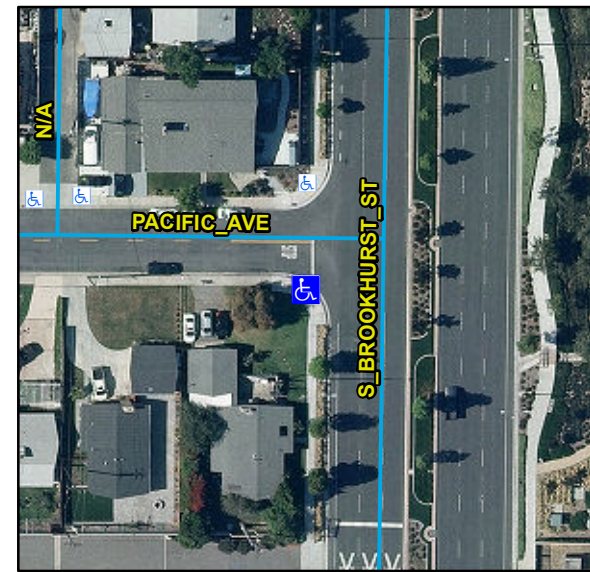
| Compliance | Description | Data | Compliance | Description | Data |
|---|---|---|---|---|---|
| Yes | Gutter Ponding | No | No | Curb Slope | 11.3 |
| No | Gutter Run Slope (%) | 6 | | Road Cross Slope (%) | N/A |

**Remove & Replace Entire Ramp. Remove & Replace Gutter.**

**R304.2.2, R304.2.1, R304.5.4, STD 1115**
