# Access Compliance Report Public Rights-of-Way (Curb Ramps)

Main Street: GARZA\_AVE Cross Street: PACIFIC\_PL Location: SE

ADA ID: RPAT211123143126 Ramp Type: Type 4 - Parallel Initial Pass/Fail: Fail Overall Compliance: No Severity Score: 4

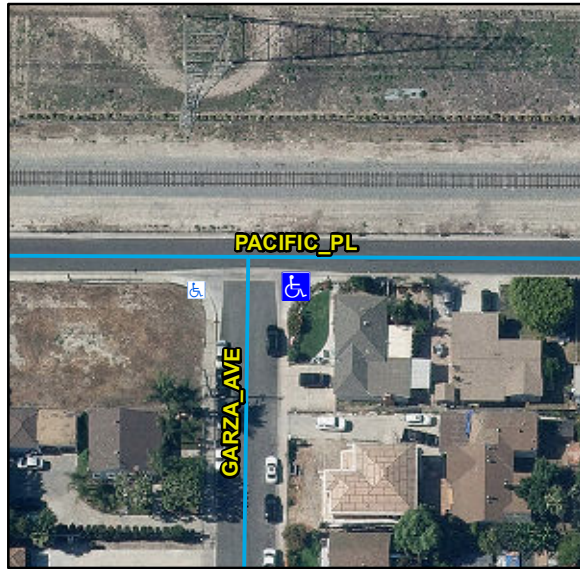
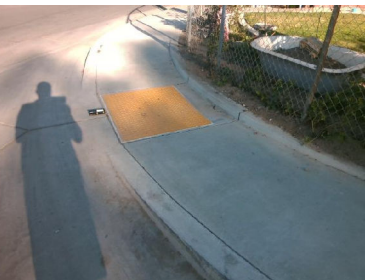
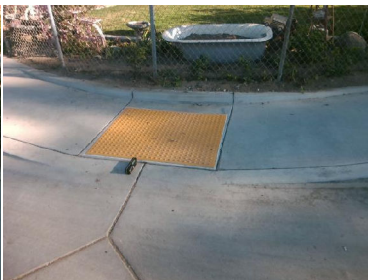
| Compliance | Description | Data | Compliance | Description | Data |
|---|---|---|---|---|---|
| No | Ramp Width LT (in) | 47 | Yes | Ramp Width RT (in) | 49 |

Remove & Replace Entire Ramp.

R304.5.1, STD 1115
