# Access Compliance Report Public Rights-of-Way (Curb Ramps)

Main Street: GARZA\_AVE Cross Street: PACIFIC\_PL Location: SW

ADA ID: RPAT211123143338 Ramp Type: Type 4 - Parallel Initial Pass/Fail: Fail Overall Compliance: No Severity Score: 5

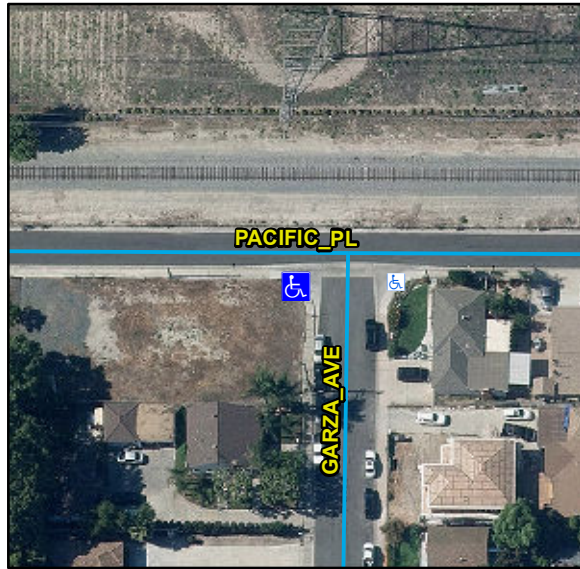
| Compliance | Description | Data | Compliance | Description | Data |
|---|---|---|---|---|---|
| Yes | Ramp Width LT (in) | 49 | No | Ramp Width RT (in) | 47 |
| No | Ramp Cross Slope LT (%) | 2.5 | Yes | Ramp Cross Slope RT (%) | 1.1 |

Remove & Replace Entire Ramp.

R304.5.1, R304.5.3, STD 1115
