# Access Compliance Report Public Rights-of-Way (Curb Ramps)

Main Street: BERRY\_AVE Cross Street: PACIFIC\_PL Location: SE

ADA ID: RPAT211123143646 Ramp Type: Type 4 - Parallel Initial Pass/Fail: Fail Overall Compliance: No Severity Score: 4

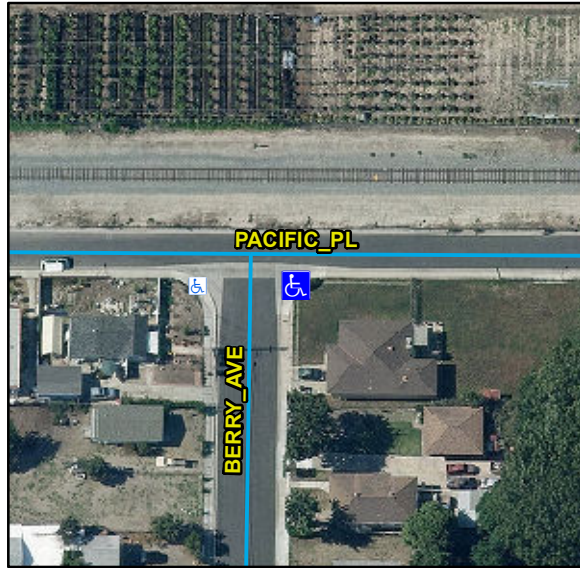
| Compliance | Description | Data | Compliance | Description | Data |
|---|---|---|---|---|---|
| No | Ramp Width LT (in) | 47 | Yes | Ramp Width RT (in) | 50 |

Possible Solutions:

Remove & Replace Entire Ramp.

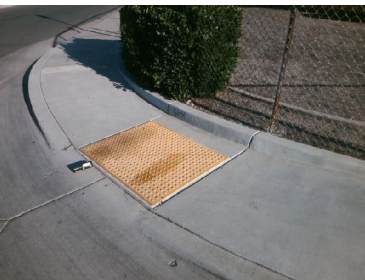
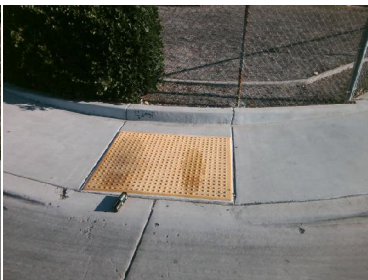
| Compliance | Description | Data | Compliance | Description | Data |
|---|---|---|---|---|---|
| N/A | Ramp Length LT (in) | 86 | N/A | Ramp Length RT (in) | 82 |
| Yes | Ramp Run Slope LT (%) | 5.3 | Yes | Ramp Run Slope RT (%) | 6.3 |
| Yes | Ramp Cross Slope LT (%) | 1.5 | Yes | Ramp Cross Slope RT (%) | 0.8 |
