# Access Compliance Report Public Rights-of-Way (Curb Ramps)

Main Street: BERRY\_AVE Cross Street: PACIFIC\_PL Location: SW

ADA ID: RPAT211123143934 Ramp Type: Type 4 - Parallel Initial Pass/Fail: Fail Overall Compliance: No Severity Score: 2

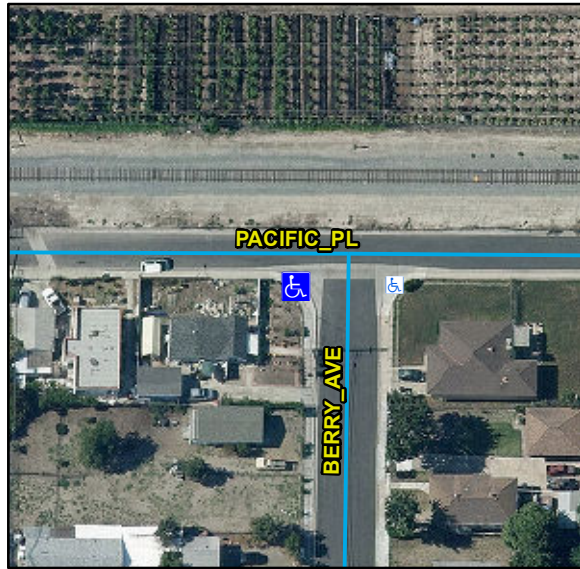
| Compliance | Description | Data | Compliance | Description | Data |
|---|---|---|---|---|---|
| No | Ramp Cross Slope LT (%) | 2.3 | Yes | Ramp Cross Slope RT (%) | 0.2 |

Possible Solutions:

Remove & Replace Entire Ramp.

R304.5.3, STD 1115

\$ 2000
