# Access Compliance Report Public Rights-of-Way (Curb Ramps)

Main Street: FILLMORE\_DR Cross Street: ARTHUR\_DR Location: SE

ADA ID: RPAT211124110158 Ramp Type: Type 4 - Parallel Initial Pass/Fail: Fail Overall Compliance: No Severity Score: 4

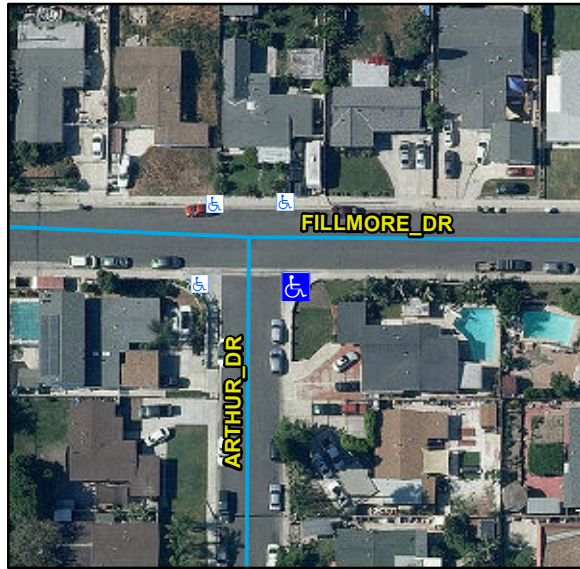
| Compliance | Description | Data | Compliance | Description | Data |
|---|---|---|---|---|---|
| Yes | Ramp Width LT (in) | 48 | No | Ramp Width RT (in) | 47 |

**Remove & Replace Curb Ramp With Two New Directional Ramps or Equivalent.**

**R304.5.1, STD 1115**
