## **Access Compliance Report Public Rights-of-Way** (Curb Ramps)

Main Street: FILLMORE_DR		Cross Street: ROCKVIEW_DR		Location:	SE
ADA ID: RPAT211124133854	Ramp Type: Type 4 - Parallel	Initial Pass/Fail: Pass	Overall Compliance: Yes	Severity Score:	0

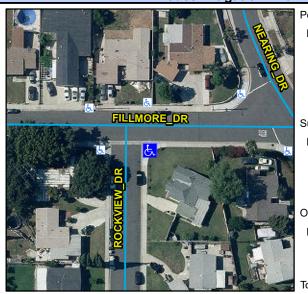
Field Measurements/Component Compliance								
1	Compliance Description		Data	Compliance Description		Data		
	N/A	Ramp Length LT (in)	122	N/A	Ramp Length RT (in)	114		
	Yes	Ramp Width LT (in)	50	Yes	Ramp Width RT (in)	48		
	Yes	Ramp Run Slope LT (%)	4.4	Yes	Ramp Run Slope RT (%)	6.5		
	Yes	Ramp Cross Slope LT (%)	0.4	Yes	Ramp Cross Slope RT (%)	0.3		
	N/A	Landing Present	Yes	Yes	DWS Provided	Yes		
	N/A	Landing Length (in)	50	Yes	DWS Contrast	Yes		
	Yes	Landing Width (in)	48	Yes	DWS Length (in)	36		
	Yes	Landing Run Slope (%)	0.9	Yes	DWS Full Width	Yes		
	Yes	Landing Cross Slope (%)	0.7		DWS Offset Type	Single		
	N/A	Landing Movement Obstructed?	No	Yes	DWS Offset Left (in)	0		
		Landing Movement Type	Curb	Yes	DWS Offset Right (in)	N/A		
	N/A	Landing Shared	No					
	N/A	Clear Space	Yes					
	N/A	Clear Space To Crosswalk (in)	48					
ו	N/A	Marked Crosswalk 1	No	N/A	Marked Crosswalk 2	No		
		Crossing 1 Direction	N		Crossing 2 Direction	W

2		Marked Crosswalk 1 Width (in)	N/A		Marked Crosswalk 2 Width (in)	N/A		
ı	N/A	Ramp Inside Crosswalk 1	N/A	N/A	Ramp Inside Crosswalk 2	N/A		
2		Crossing 1 Slope (%)	8.6		Crossing 2 Slope (%)	2.3		
ı		Crossing 1 Cross Slope (%)	0.6		Crossing 2 Cross Slope (%)	1.4		
	Yes	Gutter Ponding	No	Yes	Curb Slope	5.5		
	Yes	Gutter Lip Height (in)	0		Road Run Slope (%)	1.2		
	Yes	Gutter Run Slope (%)	3.8		Road Cross Slope (%)	1.2		
1	Yes	Gutter Cross Slope (%)	1.1	Yes	Perpendicular Joint Present	Yes		
)	Yes	es Overall Surface Condition Acceptable						
		Cross Gutter Present?	Yes		Spandrel Present?	Yes		
١		Replace Cross Gutter?	No		Replace Spandrel?	No		
	l

Possible Solutions: N/A Surveyor Notes:
