# Access Compliance Report Public Rights-of-Way (Curb Ramps)

Main Street: NEARING\_DR Cross Street: FILLMORE\_DR Location: SW

ADA ID: RPAT211124134503 Ramp Type: Type 4 - Parallel Initial Pass/Fail: Fail Overall Compliance: No Severity Score: 30

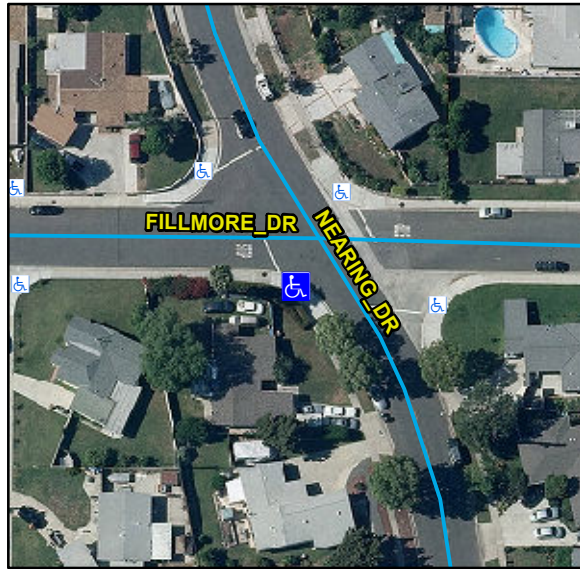
| Compliance | Description | Data | Compliance | Description | Data |
|---|---|---|---|---|---|
| No | Ramp Cross Slope LT (%) | 5.9 | No | Ramp Cross Slope RT (%) | 7.4 |

Remove & Replace Curb Ramp With Two New Directional Ramps or Equivalent.

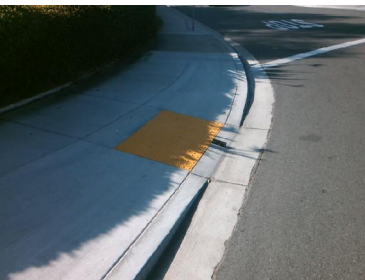
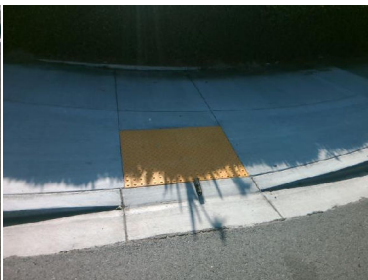
| Compliance | Description | Data | Compliance | Description | Data |
|---|---|---|---|---|---|
| N/A | Gutter Ponding | N/A | No | Curb Slope | 11 |
