# Access Compliance Report Public Rights-of-Way (Curb Ramps)

Main Street: NEARING\_DR Cross Street: FILLMORE\_DR Location: NE

ADA ID: RPAT211124140507 Ramp Type: Type 4 - Parallel Initial Pass/Fail: Fail Overall Compliance: No Severity Score: 2

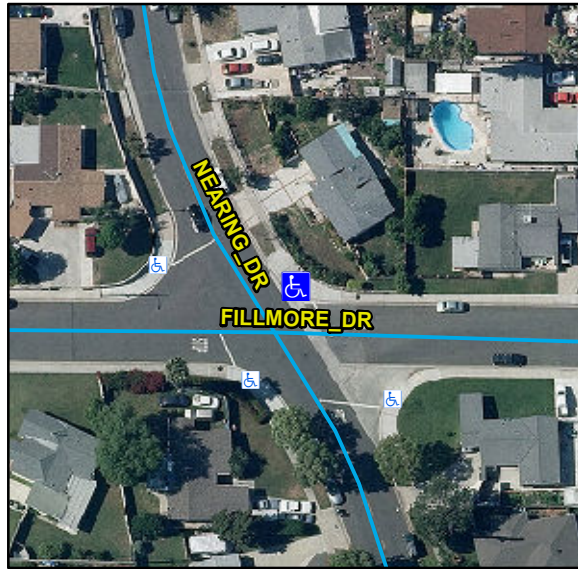
| Compliance | Description | Data | Compliance | Description | Data |
|---|---|---|---|---|---|
| No | Ramp Cross Slope LT (%) | 3 | Yes | Ramp Cross Slope RT (%) | 1.7 |

**Remove & Replace Curb Ramp With Two New Directional Ramps or Equivalent.**

**R304.5.3, STD 1115**
