# Access Compliance Report Public Rights-of-Way (Curb Ramps)

| Main Street: FILLMORE_DR | | Cross Street: NEARING_DR | | Location: | NW |
| ADA ID: RPAT211124140933 | Ramp Type: Type 4 - Parallel | Initial Pass/Fail: Fail | Overall Compliance: No | Severity Score: | 15 |

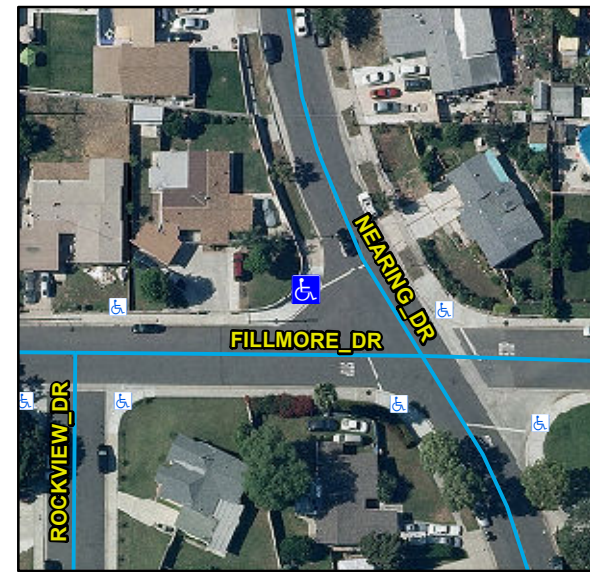
**R304.2.2, R304.5.3, STD 1115**

| Compliance | Description | Data | Compliance | Description | Data |
|---|---|---|---|---|---|
| No | Ramp Cross Slope LT (%) | 6.8 | No | Ramp Cross Slope RT (%) | 6.7 |

**Remove & Replace Curb Ramp With Two New Directional Ramps or Equivalent.**

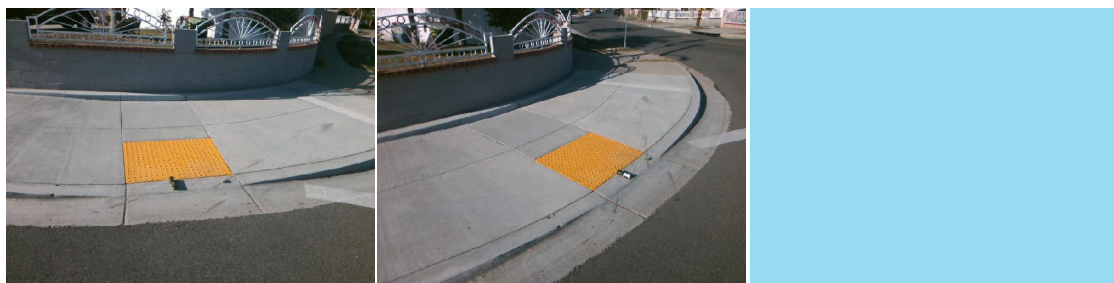
| Compliance | Description | Data | Compliance | Description | Data |
|---|---|---|---|---|---|
| N/A | Ramp Length LT (in) | 110 | N/A | Ramp Length RT (in) | 105 |
| Yes | Ramp Width LT (in) | 53 | Yes | Ramp Width RT (in) | 53 |
| Yes | Ramp Run Slope LT (%) | 4 | Yes | Ramp Run Slope RT (%) | 3.1 |
