# Access Compliance Report

## Public Rights-of-Way

### (Curb Ramps)

Main Street: AUGUSTA\_DR Cross Street: POES\_ST Location: SE

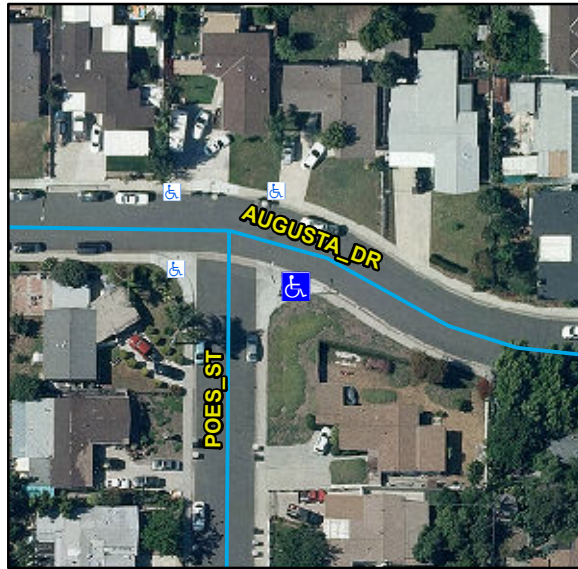
ADA ID: RPAT211124144848 Ramp Type: Type 4 - Parallel Initial Pass/Fail: Pass Overall Compliance: Yes Severity Score: 0

| Compliance | Description | Data | Compliance | Description | Data |
|---|---|---|---|---|---|
| N/A | Ramp Length LT (in) | 122 | N/A | Ramp Length RT (in) | 121 |
| Yes | Ramp Width LT (in) | 67 | Yes | Ramp Width RT (in) | 74 |
| Yes | Ramp Run Slope LT (%) | 6.5 | Yes | Ramp Run Slope RT (%) | 7.8 |
| Yes | Ramp Cross Slope LT (%) | 0.4 | Yes | Ramp Cross Slope RT (%) | 0.8 |
| Yes | Overall Surface Condition | Acceptable | | | |

Possible Solutions:

N/A
