# Access Compliance Report Public Rights-of-Way (Curb Ramps)

| Main Street: AUGUSTA_DR | | Cross Street: POES_ST | | Location: | SE |
| ADA ID: RPAT211124145649 | Ramp Type: Type 4 - Parallel | Initial Pass/Fail: Fail | Overall Compliance: No | Severity Score: | 15 |

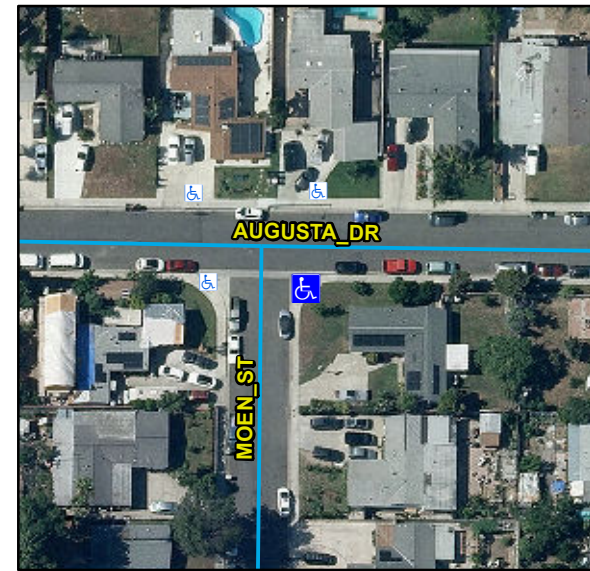
| Compliance | Description | Data | Compliance | Description | Data |
|---|---|---|---|---|---|
| No | Ramp Run Slope LT (%) | 8.5 | Yes | Ramp Run Slope RT (%) | 7.4 |

**Remove & Replace Curb Ramp With Two New Directional Ramps or Equivalent. Replace Cross Gutter.**
