# Access Compliance Report Public Rights-of-Way (Curb Ramps)

Main Street: S\_BROOKHURST\_ST Cross Street: BALL\_RD Location: SW

ADA ID: RPAT211129091958 Ramp Type: Type 1 - Perpendicular Diagonal Initial Pass/Fail: Fail Overall Compliance: No Severity Score: 2

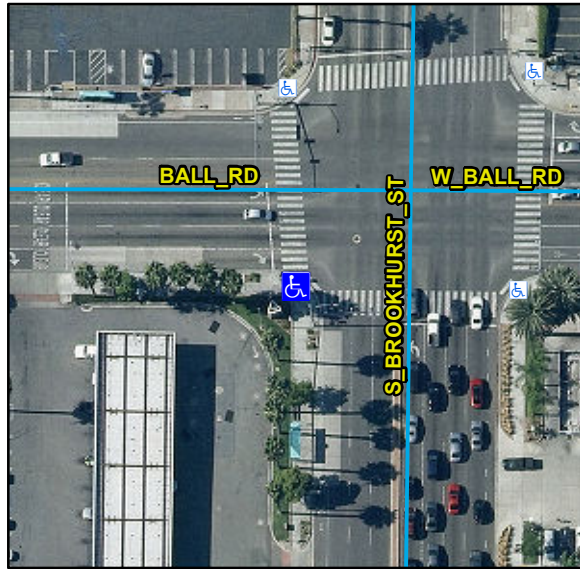
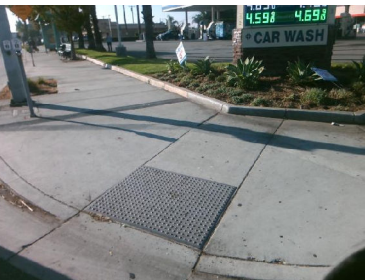
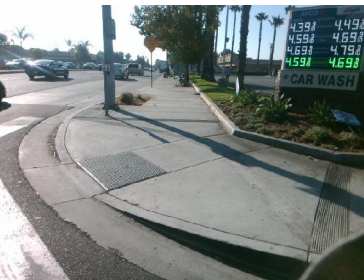
| Compliance | Description | Data | Compliance | Description | Data |
|---|---|---|---|---|---|
| No | Ramp Cross Slope (%) | 2.9 | N/A | Flare Traversable LT | N/A |

Remove & Replace Curb Ramp With Two New Directional Ramps or Equivalent.
