Main Street: W BALL RD Cross Street: S BROOKHURST ST Location: SE

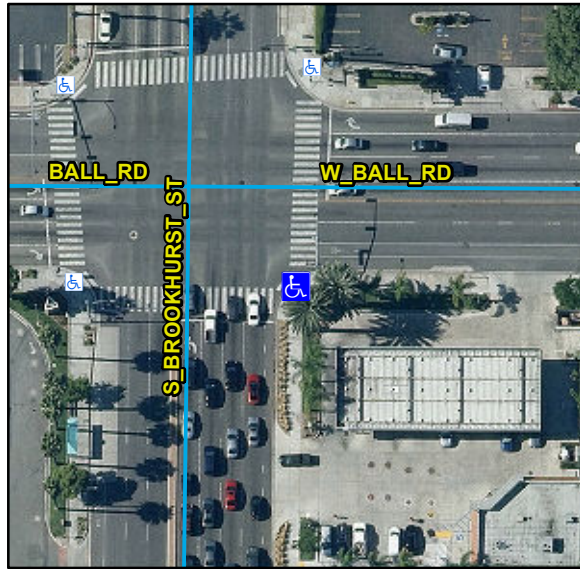
ADA ID: RPAT211129092542 Ramp Type: Type 1 - Perpendicular Diagonal Initial Pass/Fail: Pass Overall Compliance: No Severity Score: 2

| Compliance | Description | Data | Compliance | Description | Data |
|---|---|---|---|---|---|
| No | Landing Cross Slope (%) | 2.2 | Yes | DWS Provided | Yes |

Remove & Replace Landing.

R304.2.1, R304.5.3, STD 1115
