# Access Compliance Report Public Rights-of-Way (Curb Ramps)

Main Street: S\_BROOKHURST\_ST Cross Street: W\_BALL\_RD Location: NE

ADA ID: RPAT211129093356 Ramp Type: Type 1 - Perpendicular Diagonal Initial Pass/Fail: Pass Overall Compliance: No Severity Score: 5

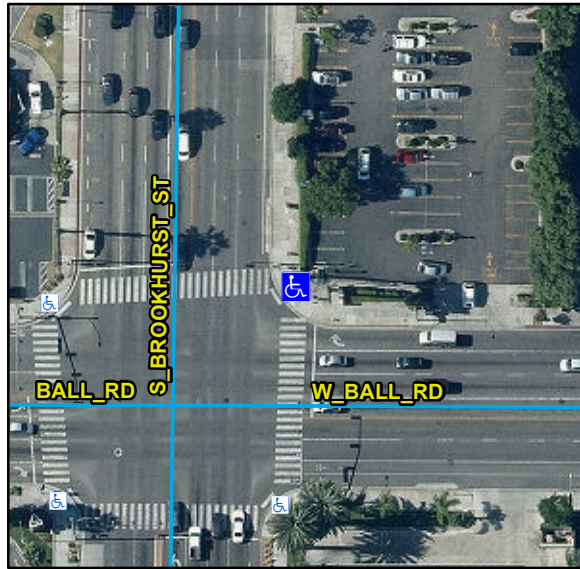
| Compliance | Description | Data | Compliance | Description | Data |
|---|---|---|---|---|---|
| Yes | Gutter Ponding | No | No | Curb Slope | 8 |
| No | Gutter Run Slope (%) | 6.4 | | Road Cross Slope (%) | 3.3 |

Remove & Replace Curb Ramp With Two New Directional Ramps or Equivalent. Remove & Replace Gutter.

R304.2.2, R304.2.1, R304.5.4, STD 1115
