# Access Compliance Report Public Rights-of-Way (Curb Ramps)

| Main Street: N/A | | Cross Street: BALL_RD | | Location: | NE |
| ADA ID: RPAT211129094815 | Ramp Type:Type 1 - Perpendicular | Initial Pass/Fail: Fail | Overall Compliance: No | Severity Score: | 15 |

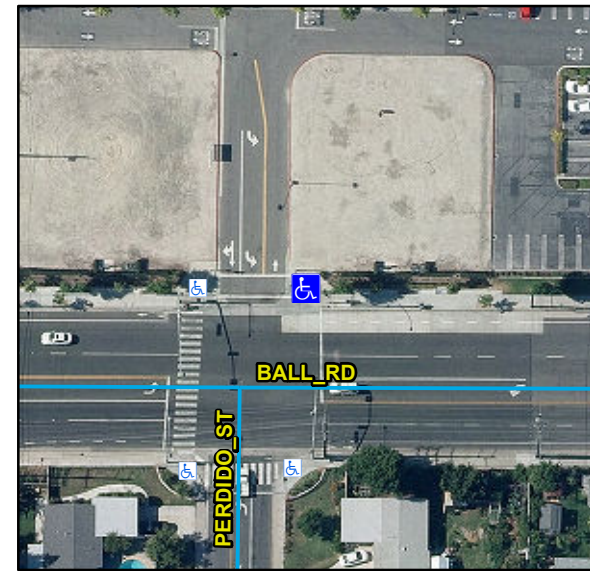
| Compliance | Description | Data | Compliance | Description | Data |
|---|---|---|---|---|---|
| No | Ramp Run Slope (%) | 9.5 | N/A | Flare Slope LT (%) | N/A |

**Remove & Replace Entire Ramp.**

**R304.2.2, STD 1115**

**\$ 3080**
