# Access Compliance Report Public Rights-of-Way (Curb Ramps)

Main Street: BALL\_RD Cross Street: N/A Location: NW

ADA ID: RPAT211129095145 Ramp Type: Type 1 - Perpendicular Diagonal Initial Pass/Fail: Fail Overall Compliance: No Severity Score: 15

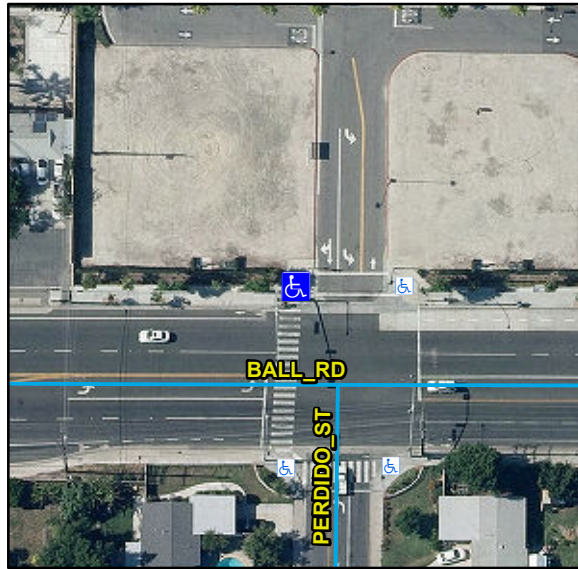
| Compliance | Description | Data | Compliance | Description | Data |
|---|---|---|---|---|---|
| No | Ramp Run Slope (%) | 8.7 | N/A | Flare Slope LT (%) | N/A |

Remove & Replace Curb Ramp With Two New Directional Ramps or Equivalent.

R304.2.2, STD 1115
