# Access Compliance Report Public Rights-of-Way (Curb Ramps)

Main Street: PACIFIC\_AVE Cross Street: MAGNOLIA\_AVE Location: NE

ADA ID: RPAT211129103724 Ramp Type: Type 1 - Perpendicular Initial Pass/Fail: Pass Overall Compliance: No Severity Score: 4

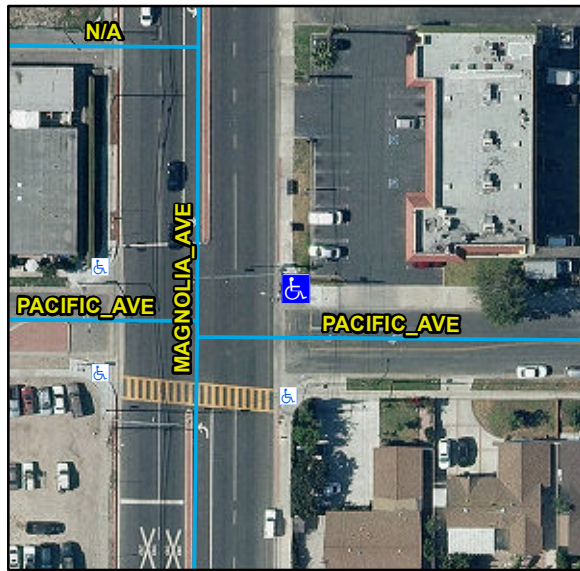
| Compliance | Description | Data | Compliance | Description | Data |
|---|---|---|---|---|---|
| No | Landing Cross Slope (%) | 2.6 | Yes | DWS Provided | Yes |
| N/A | Landing Movement Obstructed? | Yes | Yes | DWS Contrast | Yes |
| | Landing Movement Type | Curb | Yes | DWS Length (in) | 38 |

Remove & Replace Landing. Utility Present.

R304.2.1, R304.5.3, STD 1115
