# Access Compliance Report Public Rights-of-Way (Curb Ramps)

Main Street: PACIFIC\_AVE Cross Street: MAGNOLIA\_AVE Location: SE

ADA ID: RPAT211129104147 Ramp Type: Type 4 - Parallel Initial Pass/Fail: Fail Overall Compliance: No Severity Score: 30

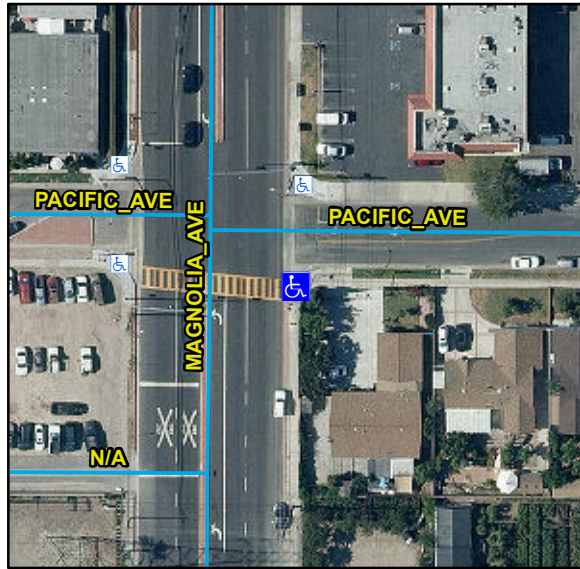
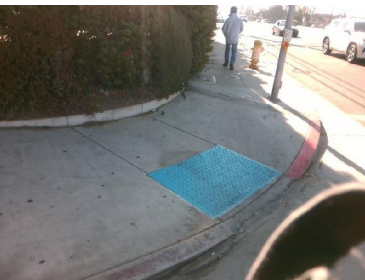
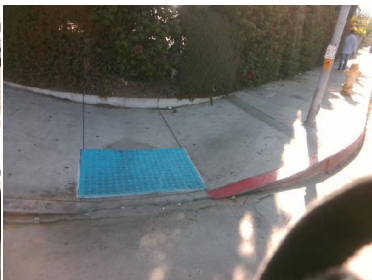
| Compliance | Description | Data | Compliance | Description | Data |
|---|---|---|---|---|---|
| No | Ramp Cross Slope LT (%) | 7.7 | Yes | Ramp Cross Slope RT (%) | 0.7 |
| N/A | Gutter Ponding | N/A | No | Curb Slope | 10.5 |

Remove & Replace Curb Ramp With Two New Directional Ramps or Equivalent.

R304.2.2, R304.5.3, STD 1115
