# Access Compliance Report Public Rights-of-Way (Curb Ramps)

Main Street: SYRACUSE\_AVE Cross Street: MAGNOLIA\_AVE Location: NW

ADA ID: RPAT211129105502 Ramp Type: Type 4 - Parallel Initial Pass/Fail: Fail Overall Compliance: No Severity Score: 2

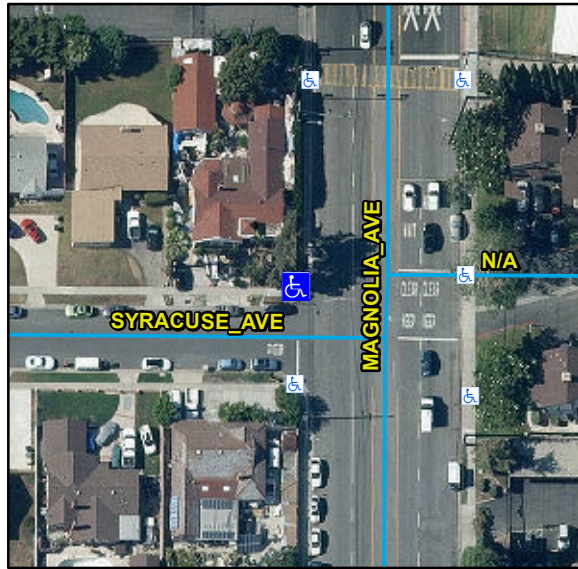
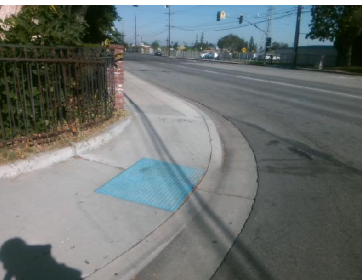
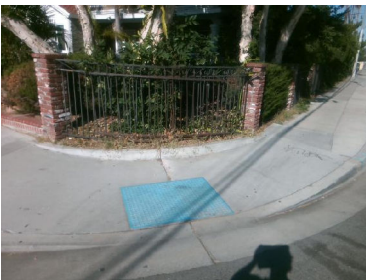
| Compliance | Description | Data | Compliance | Description | Data |
|---|---|---|---|---|---|
| No | Ramp Cross Slope LT (%) | 2.1 | No | Ramp Cross Slope RT (%) | 3.6 |

Remove & Replace Curb Ramp With Two New Directional Ramps or Equivalent.

R304.5.3, STD 1115
