# Access Compliance Report Public Rights-of-Way (Curb Ramps)

Main Street: SYRACUSE\_AVE Cross Street: MAGNOLIA\_AVE Location: SW

ADA ID: RPAT211129105952 Ramp Type: Type 4 - Parallel Initial Pass/Fail: Fail Overall Compliance: No Severity Score: 2

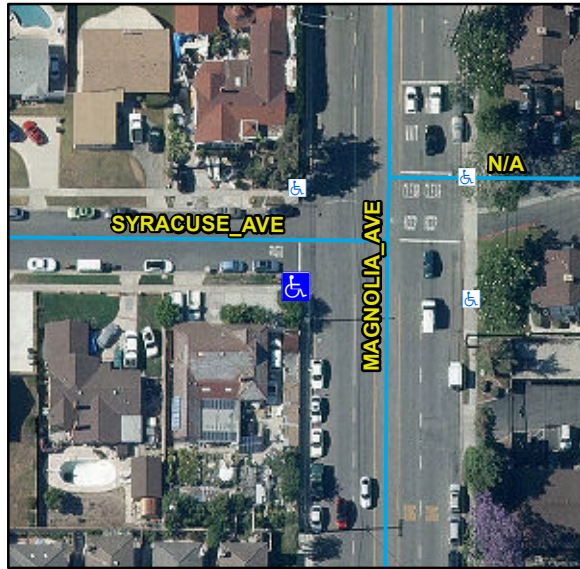
| Compliance | Description | Data | Compliance | Description | Data |
|---|---|---|---|---|---|
| Yes | Ramp Cross Slope LT (%) | 1.6 | No | Ramp Cross Slope RT (%) | 2.8 |

**Remove & Replace Curb Ramp With Two New Directional Ramps or Equivalent.**

**R304.5.3, STD 1115**
