Access Compliance Report Public Rights-of-Way (Curb Ramps)

Main Street: MOSSLER_ST **Cross Street:** YORKSHIRE_AVE **Location:** NE

ADA ID: RPAT211129124918 **Ramp Type:** Type 4 - Parallel **Initial Pass/Fail:** Fail **Overall Compliance:** No **Severity Score:** 2

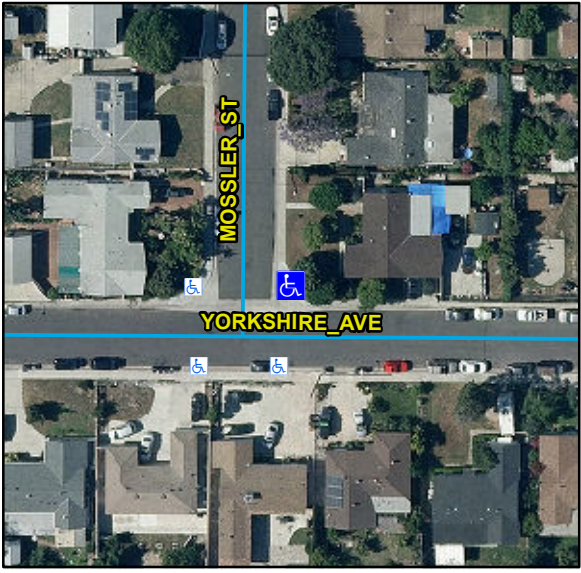
Compliance	Description	Data	Compliance	Description	Data
N/A	Ramp Length LT (in)	144	N/A	Ramp Length RT (in)	145
Yes	Ramp Width LT (in)	58	Yes	Ramp Width RT (in)	58
Yes	Ramp Run Slope LT (%)	3.9	Yes	Ramp Run Slope RT (%)	4.7
No	Ramp Cross Slope LT (%)	2.7	No	Ramp Cross Slope RT (%)	2.8
N/A	Landing Present	N/A	N/A	DWS Provided	N/A
N/A	Landing Length (in)	N/A	N/A	DWS Contrast	N/A
N/A	Landing Width (in)	N/A	N/A	DWS Length (in)	N/A
N/A	Landing Run Slope (%)	N/A	N/A	DWS Full Width	N/A
N/A	Landing Cross Slope (%)	N/A		DWS Offset Type	N/A
N/A	Landing Movement Obstructed?	N/A	N/A	DWS Offset Left (in)	N/A
	Landing Movement Type	N/A	N/A	DWS Offset Right (in)	N/A
N/A	Landing Shared	N/A			
N/A	Clear Space	Yes			
N/A	Clear Space To Crosswalk (in)	N/A			
N/A	Marked Crosswalk 1	No	N/A	Marked Crosswalk 2	No
	Crossing 1 Direction	W		Crossing 2 Direction	S
N/A	Marked Crosswalk 1 Width (in)	N/A		Marked Crosswalk 2 Width (in)	N/A

N/A	Ramp Inside Crosswalk 1	N/A	N/A	Ramp Inside Crosswalk 2	N/A
	Crossing 1 Slope (%)	1.2		Crossing 2 Slope (%)	7
	Crossing 1 Cross Slope (%)	0.6		Crossing 2 Cross Slope (%)	0.3
N/A	Gutter Ponding	N/A	Yes	Curb Slope	6.8
Yes	Gutter Lip Height (in)	0		Road Run Slope (%)	0.1
N/A	Gutter Run Slope (%)	N/A		Road Cross Slope (%)	2.3
N/A	Gutter Cross Slope (%)	N/A	Yes	Perpendicular Joint Present	Yes
Yes	Overall Surface Condition	Acceptable			
	Cross Gutter Present?	Yes		Spandrel Present?	Yes
	Replace Cross Gutter?	No		Replace Spandrel?	No

Possible Solutions:
Remove & Replace Curb Ramp With Two New Directional Ramps or Equivalent.

OC Std/PROW:
 R304.5.3, STD 1115

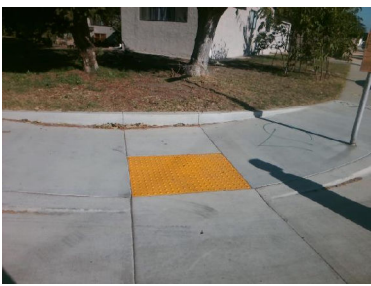
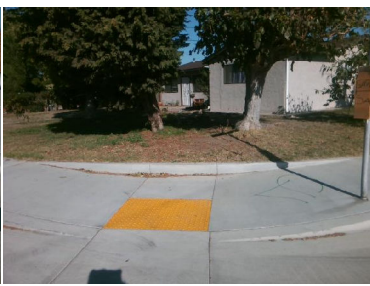
Compliance	Description	Data	Compliance	Description	Data
Yes	Obstructions Present?	No	N/A	Utilities Present?	Yes
	Obstruction Types	N/A		Utility Types	
	Obstruction Dimensions	N/A		Street Sign
