# Access Compliance Report Public Rights-of-Way (Curb Ramps)

| Main Street: YORKSHIRE_AVE | | Cross Street: MOSSLER_ST | | Location: | NW |
| ADA ID: RPAT211129125257 | Ramp Type: Type 4 - Parallel | Initial Pass/Fail: Fail | Overall Compliance: No | Severity Score: | 2 |

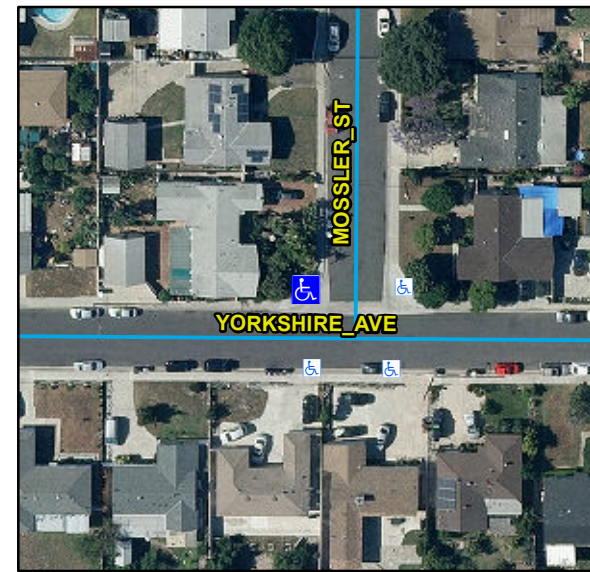
| Compliance | Description | Data | Compliance | Description | Data |
|---|---|---|---|---|---|
| Yes | Ramp Cross Slope LT (%) | 1.4 | No | Ramp Cross Slope RT (%) | 3 |

**Remove & Replace Curb Ramp With Two New Directional Ramps or Equivalent.**

**R304.5.3, STD 1115**
