# Access Compliance Report Public Rights-of-Way (Curb Ramps)

Main Street: DALE\_ST Cross Street: HOPI\_RD Location: SW

ADA ID: RPAT211129130528 Ramp Type: Type 1 - Perpendicular Diagonal Initial Pass/Fail: Pass Overall Compliance: No Severity Score: 5

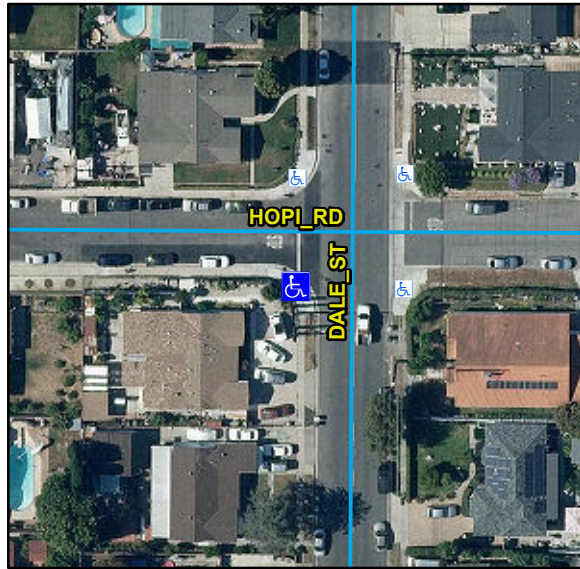
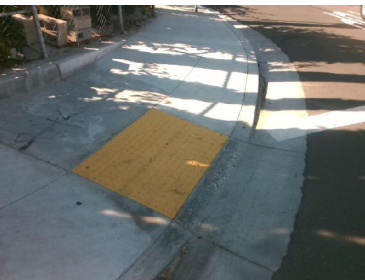
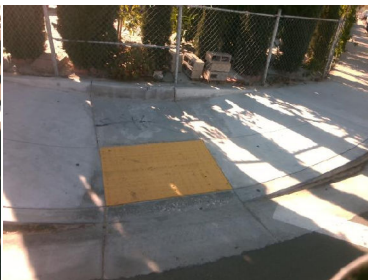
| Compliance | Description | Data | Compliance | Description | Data |
|---|---|---|---|---|---|
| Yes | Gutter Ponding | No | No | Curb Slope | 9.6 |
| No | Gutter Run Slope (%) | 9.6 | | Road Cross Slope (%) | 4.5 |

Remove & Replace Curb Ramp With Two New Directional Ramps or Equivalent. Remove & Replace Gutter.
