# Access Compliance Report Public Rights-of-Way (Curb Ramps)

Main Street: HOPI\_RD Cross Street: DALE\_ST Location: NW

ADA ID: RPAT211129131127 Ramp Type: Type 1 - Perpendicular Diagonal Initial Pass/Fail: Pass Overall Compliance: No Severity Score: 5

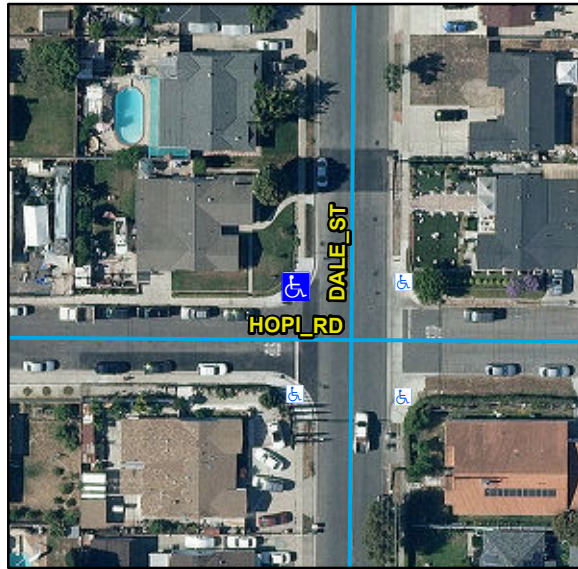
| Compliance | Description | Data | Compliance | Description | Data |
|---|---|---|---|---|---|
| No | Gutter Run Slope (%) | 5.2 | | Road Cross Slope (%) | 0.8 |

Remove & Replace Landing. Remove & Replace Gutter.
