# Access Compliance Report Public Rights-of-Way (Curb Ramps)

Main Street: HOPI\_RD Cross Street: DALE\_ST Location: N

ADA ID: RPAT211129131630 Ramp Type: Type 7 - Directional 2 Initial Pass/Fail: Fail Overall Compliance: No Severity Score: 16

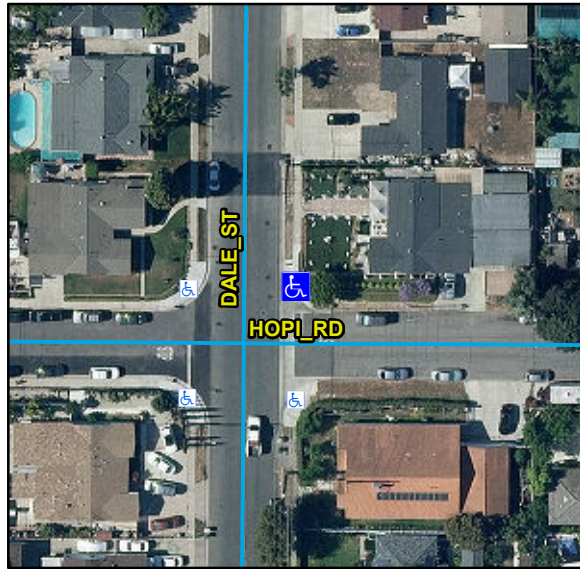
| Compliance | Description | Data | Compliance | Description | Data |
|---|---|---|---|---|---|
| No | Ramp Run Slope (%) | 11.4 | N/A | Flare Slope LT (%) | N/A |
| No | Ramp Cross Slope (%) | 2.4 | N/A | Flare Traversable LT | N/A |

Remove & Replace Entire Ramp.
