# Access Compliance Report Public Rights-of-Way (Curb Ramps)

Main Street: HOPI\_RD Cross Street: DALE\_ST Location: S

ADA ID: RPAT211129132401 Ramp Type: Type 7 - Directional 2 Initial Pass/Fail: Fail Overall Compliance: No Severity Score: 2

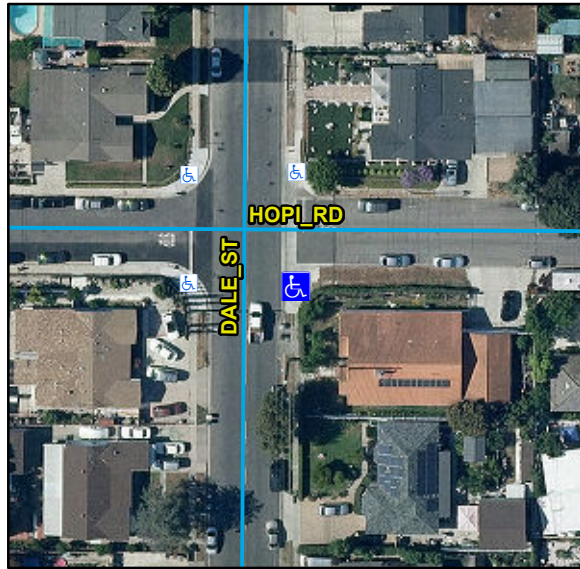
| Compliance | Description | Data | Compliance | Description | Data |
|---|---|---|---|---|---|
| No | Ramp Cross Slope (%) | 2.6 | N/A | Flare Traversable LT | N/A |

Possible Solutions:

Remove & Replace Entire Ramp.

OC Std/PROW:

R304.5.3, STD 1115
