# Access Compliance Report Public Rights-of-Way (Curb Ramps)

Main Street: POES\_ST Cross Street: ORANGEWOOD\_AVE Location: SW

ADA ID: RPAT211130085901 Ramp Type: Type 4 - Parallel Initial Pass/Fail: Fail Overall Compliance: No Severity Score: 30

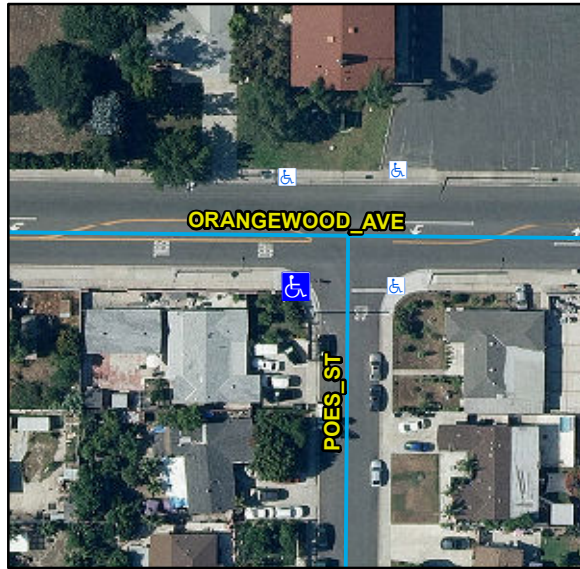
| Compliance | Description | Data | Compliance | Description | Data |
|---|---|---|---|---|---|
| No | Ramp Cross Slope LT (%) | 7.3 | No | Ramp Cross Slope RT (%) | 7 |

**Remove & Replace Curb Ramp With Two New Directional Ramps or Equivalent.**

**R304.5.3, STD 1115**

Total Cost: \$ 4000
