# Access Compliance Report Public Rights-of-Way (Curb Ramps)

Main Street: YANA\_DR Cross Street: ORANGEWOOD\_AVE Location: SW

ADA ID: RPAT211130091409 Ramp Type: Type 4 - Parallel Initial Pass/Fail: Fail Overall Compliance: No Severity Score: 60

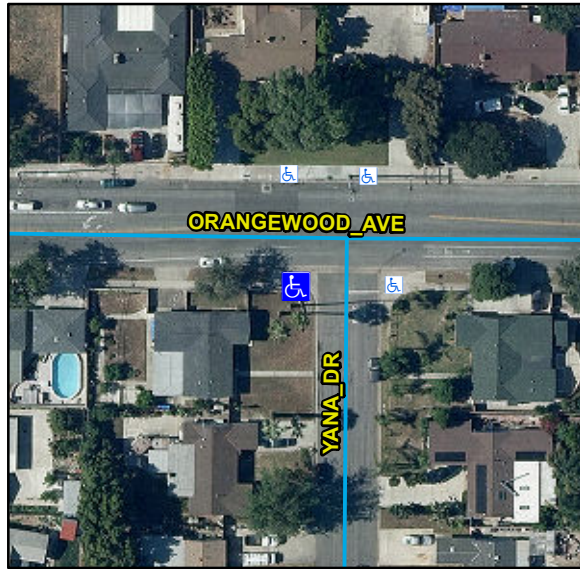
| Compliance | Description | Data | Compliance | Description | Data |
|---|---|---|---|---|---|
| No | Ramp Run Slope LT (%) | 17 | No | Ramp Run Slope RT (%) | 11.7 |
| No | Ramp Cross Slope LT (%) | 5.1 | No | Ramp Cross Slope RT (%) | 10.7 |

**Remove & Replace Curb Ramp With Two New Directional Ramps or Equivalent.**

**R304.3.2, R304.5.3, STD 1115**
