# Access Compliance Report Public Rights-of-Way (Curb Ramps)

| Main Street: ORANGEWOOD_AVE | | Cross Street: YANA_DR | | Location: | SE |
| ADA ID: RPAT211130091735 | Ramp Type: Type 4 - Parallel | Initial Pass/Fail: Fail | Overall Compliance: No | Severity Score: | 45 |

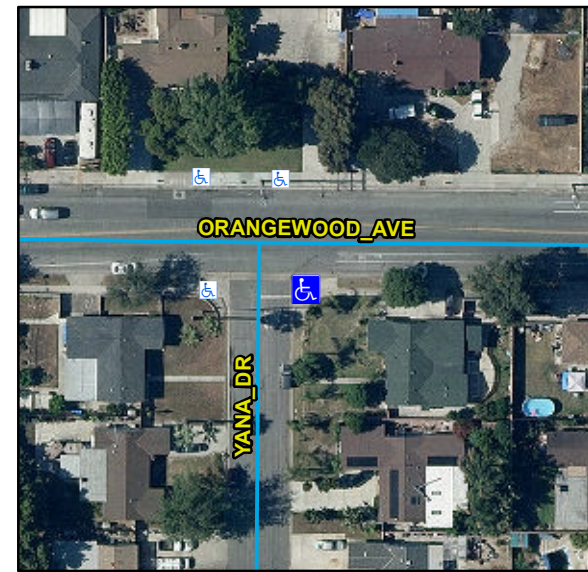
| Compliance | Description | Data | Compliance | Description | Data |
|---|---|---|---|---|---|
| No | Ramp Run Slope LT (%) | 8.4 | No | Ramp Run Slope RT (%) | 13.9 |
| No | Ramp Cross Slope LT (%) | 6.4 | No | Ramp Cross Slope RT (%) | 4.9 |

**Remove & Replace Curb Ramp With Two New Directional Ramps or Equivalent.**

**R304.3.2, R304.5.3, STD 1115**

Total Cost: \$ 4000
