# Access Compliance Report Public Rights-of-Way (Curb Ramps)

Main Street: ORANGEWOOD\_AVE Cross Street: MOEN\_ST Location: SE

ADA ID: RPAT211130092611 Ramp Type: Type 1 - Perpendicular Diagonal Initial Pass/Fail: Pass Overall Compliance: No Severity Score: 0

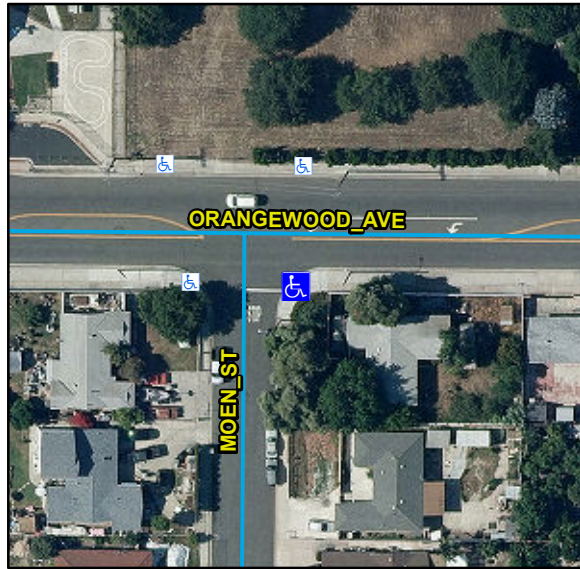
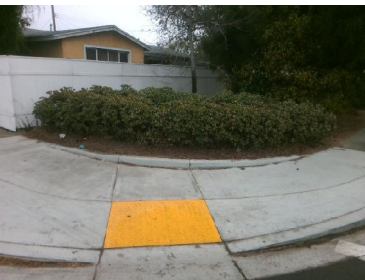
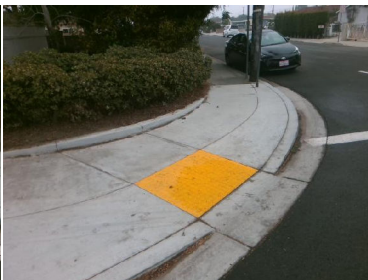
| Compliance | Description | Data | Compliance | Description | Data |
|---|---|---|---|---|---|
| Yes | Gutter Ponding | No | No | Curb Slope | 6.3 |

**Remove & Replace Curb Ramp With Two New Directional Ramps or Equivalent.**

**R304.2.2, R304.2.1, STD 1115**
