# Access Compliance Report Public Rights-of-Way (Curb Ramps)

Main Street: MOEN\_ST Cross Street: ORANGEWOOD\_AVE Location: SW

ADA ID: RPAT211130093101 Ramp Type: Type 1 - Perpendicular Diagonal Initial Pass/Fail: Pass Overall Compliance: No Severity Score: 0

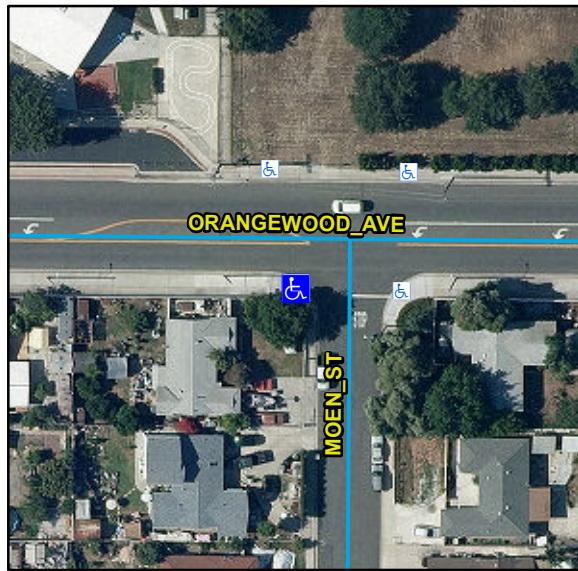
| Compliance | Description | Data | Compliance | Description | Data |
|---|---|---|---|---|---|
| Yes | Gutter Ponding | No | No | Curb Slope | 7.5 |

Remove & Replace Curb Ramp With Two New Directional Ramps or Equivalent.

R304.2.2, R304.2.1, STD 1115
