# Access Compliance Report Public Rights-of-Way (Curb Ramps)

Main Street: ORANGEWOOD\_AVE Cross Street: MOSSLER\_ST Location: SE

ADA ID: RPAT211130093644 Ramp Type: Type 1 - Perpendicular Diagonal Initial Pass/Fail: Pass Overall Compliance: No Severity Score: 2

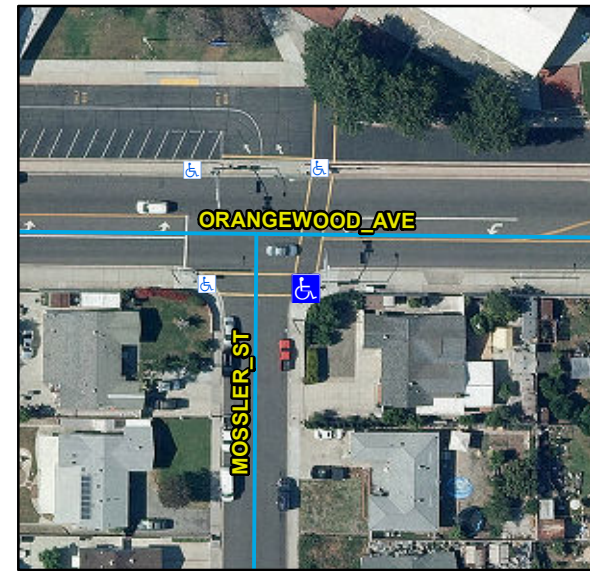
| Compliance | Description | Data | Compliance | Description | Data |
|---|---|---|---|---|---|
| No | Gutter Cross Slope (%) | 3.2 | | | |

Remove & Replace Landing. Remove & Replace Gutter. Utility Present.
