# Access Compliance Report Public Rights-of-Way (Curb Ramps)

Main Street: MOSSLER\_ST Cross Street: ORANGEWOOD\_AVE Location: SW

ADA ID: RPAT211130094142 Ramp Type: Type 1 - Perpendicular Diagonal Initial Pass/Fail: Pass Overall Compliance: No Severity Score: 2

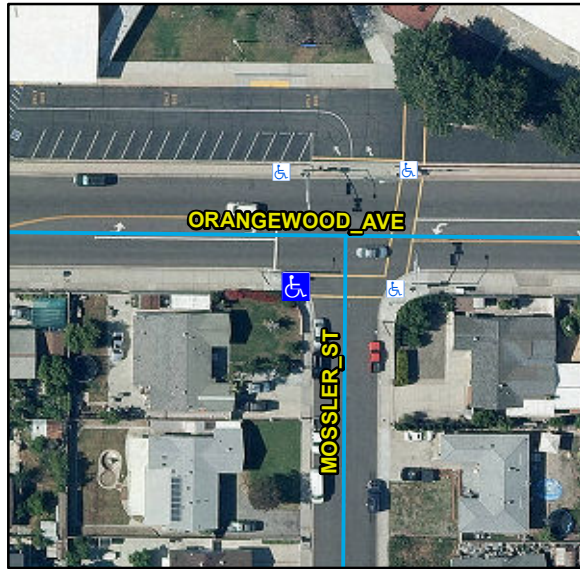
| Compliance | Description | Data | Compliance | Description | Data |
|---|---|---|---|---|---|
| N/A | Landing Present | Yes | N/A | Flare Type RT | |
| N/A | Landing Length (in) | 48 | | | Sloped |
| N/A | Landing Movement Obstructed? | Yes | Yes | DWS Contrast | Yes |
| | Landing Movement Type | Curb | Yes | DWS Length (in) | 36 |

Remove & Replace Landing.

R304.2.1, STD 1115
