# Access Compliance Report Public Rights-of-Way (Curb Ramps)

Main Street: HOPI\_RD Cross Street: POES\_ST Location: SE

ADA ID: RPAT211130095401 Ramp Type: Type 4 - Parallel Initial Pass/Fail: Pass Overall Compliance: No Severity Score: 5

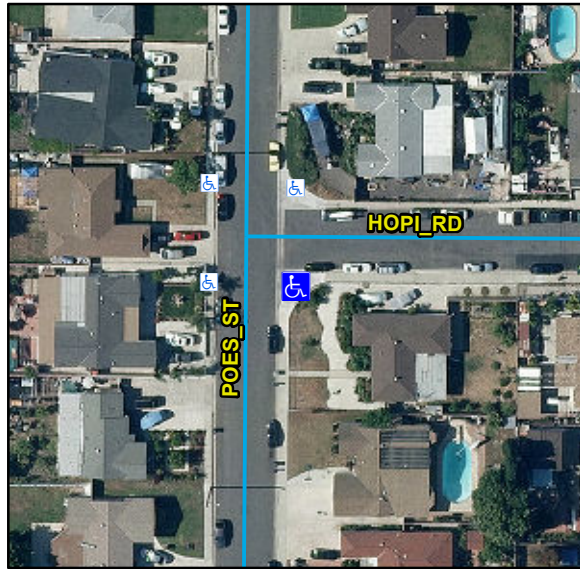
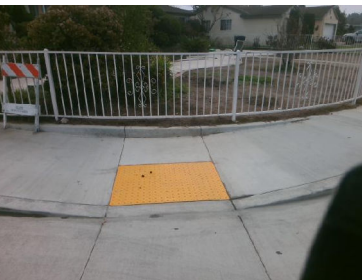
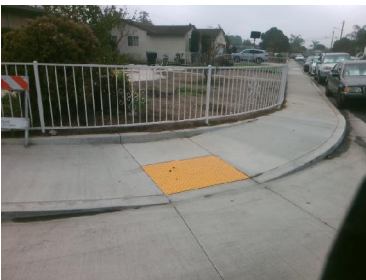
| Compliance | Description | Data | Compliance | Description | Data |
|---|---|---|---|---|---|
| No | Gutter Run Slope (%) | 7.5 | | Road Cross Slope (%) | 1.5 |

Remove & Replace Gutter.

R304.5.4, STD 1115
