# Access Compliance Report Public Rights-of-Way (Curb Ramps)

Main Street: POES\_ST Cross Street: HOPI\_RD Location: NE

ADA ID: RPAT211130095827 Ramp Type: Type 4 - Parallel Initial Pass/Fail: Pass Overall Compliance: No Severity Score: 5

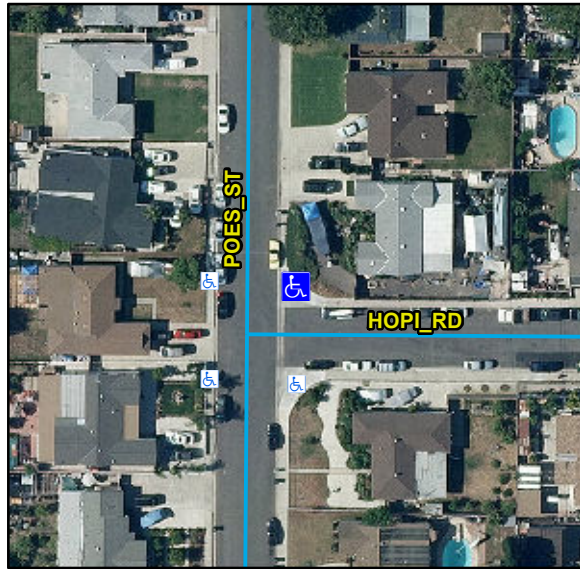
| Compliance | Description | Data | Compliance | Description | Data |
|---|---|---|---|---|---|
| No | Landing Run Slope (%) | 2.1 | Yes | DWS Full Width | Yes |
| No | Landing Cross Slope (%) | 8 | | DWS Offset Type | Single |

Remove & Replace Landing.
